RESTORATION OF A 1935 SILVER KING TRACTOR

By Dave McClary

Preface: The following is an account of the restoration of a 1935 Silver King R-38 tractor in the years 1998 to 2001. Much of this is taken from articles written for the Quinebaug Valley Engineers Association monthly newsletter as the restoration work progressed. These have been edited to shorten and improve continuity. The tractor was originally purchased and used for haying in Stonington, Connecticut, on local farms. It had been in storage for the previous twenty years or so and was then given to my next door neighbor by the owner. The neighbor and I considered that it should be restored. He being more interested in restoring automobiles and I, having restored several antique tractors and being active in tractor pulling events and antique machinery shows, decided that I should undertake the restoration and take it to the various shows when completed. I considered this a privilege well worth the many hours of work and expense involved.

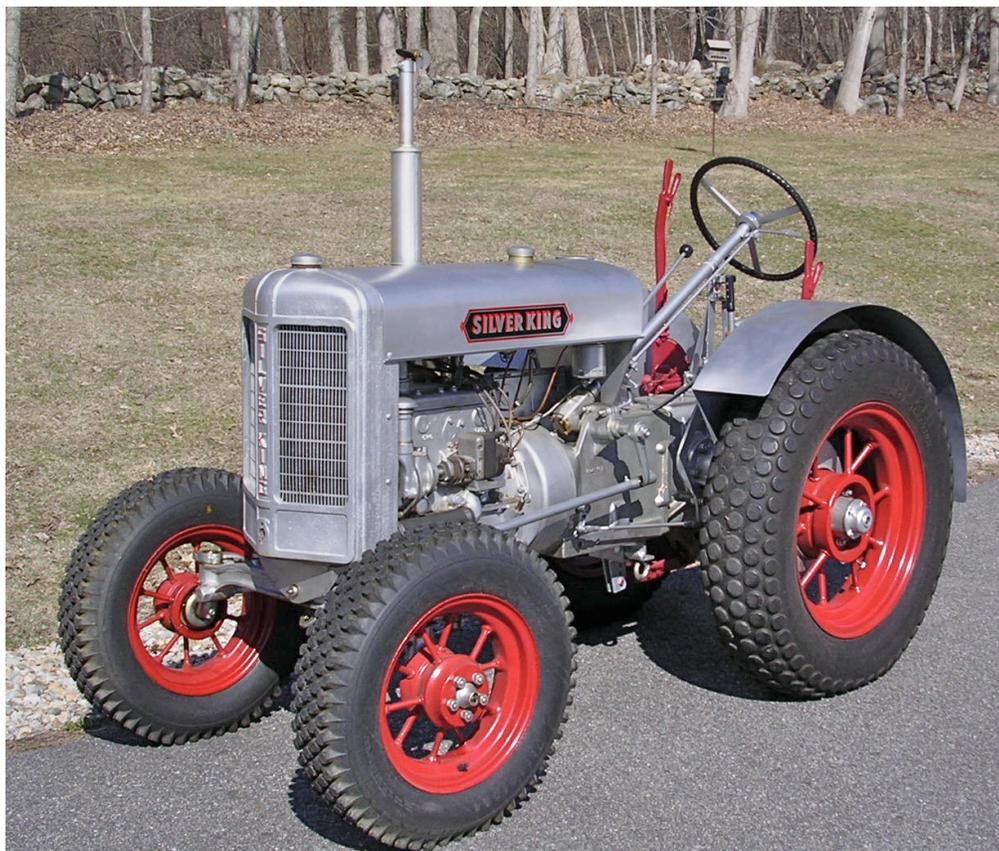
In mid September, 1998 I brought the Silver King tractor home to restore. There was some excitement after removing the side mount mower, finding the name plate and discovering it was serial number 336. The Fate-Root-Heath Manufacturing Co. started making Plymouth tractors in 1934 beginning with number 101 and as I subsequently learned, there were 214 Plymouths made before the name was changed to Silver King. This was therefore the 22nd Silver King made and the 11th made in 1935.

Overall appearance was excellent with little rust evident. Engine oil was clean and the engine turned easily. The magneto worked after cleaning and some gas line work was needed. I expected to have it at the Fall (1998) Brooklyn, CT, show, running or not. Well it was not, but it tows easily with the Oliver 60 and someone to steer. One rear tire inner tube had to be replaced. While trying to get it started, I found the exhaust manifold rusted out with holes on the back side. A replacement was later purchased but the configuration was somewhat different. The carburetor and exhaust connections are two inches higher and one inch further out. Some plumbing gets the exhaust out the side under the integral hood and gas tank, and an upright muffler looks right, although the original stuck out horizontally. Some modifications to the throttle and governor linkage would be necessary. It was noted that a wire used on the original linkage would have controlled the governor action. I wondered why it was there but pressed on in an effort to get the engine running. I wanted to drive it around with some used engine oil in the rear end to help flush out the heavy oil and water mix that had drained out. Hand cranking is the starting method and my battery ran down several times. Nary a cough was heard. Rechecking carburetion and ignition proved fruitless. I concluded there was insufficient compression to draw a charge into the cylinder. A piece of cardboard placed over a spark plug hole barely lifted on the compression stroke. I decided to overhaul the engine first. Curious about the wired throttle linkage, the back cover of the governor was removed to permit looking inside. What governor? There were no internals in there except the yoke that moves the external lever. A new governor was ordered that "should work". Well it didn't. Although it would fit the engine, placement of the external lever away from the mounting flange caused an interference with the radiator support
