RESTORATION OF A 1935 SILVER KING TRACTOR

By Dave McClary

Preface: The following is an account of the restoration of a 1935 Silver King R-38 tractor in the years 1998 to 2001. Much of this is taken from articles written for the Quinebaug Valley Engineers Association monthly newsletter as the restoration work progressed. These have been edited to shorten and improve continuity. The tractor was originally purchased and used for haying in Stonington, Connecticut, on local farms. It had been in storage for the previous twenty years or so and was then given to my next door neighbor by the owner. The neighbor and I considered that it should be restored. He being more interested in restoring automobiles and I, having restored several antique tractors and being active in tractor pulling events and antique machinery shows, decided that I should undertake the restoration and take it to the various shows when completed. I considered this a privilege well worth the many hours of work and expense involved.

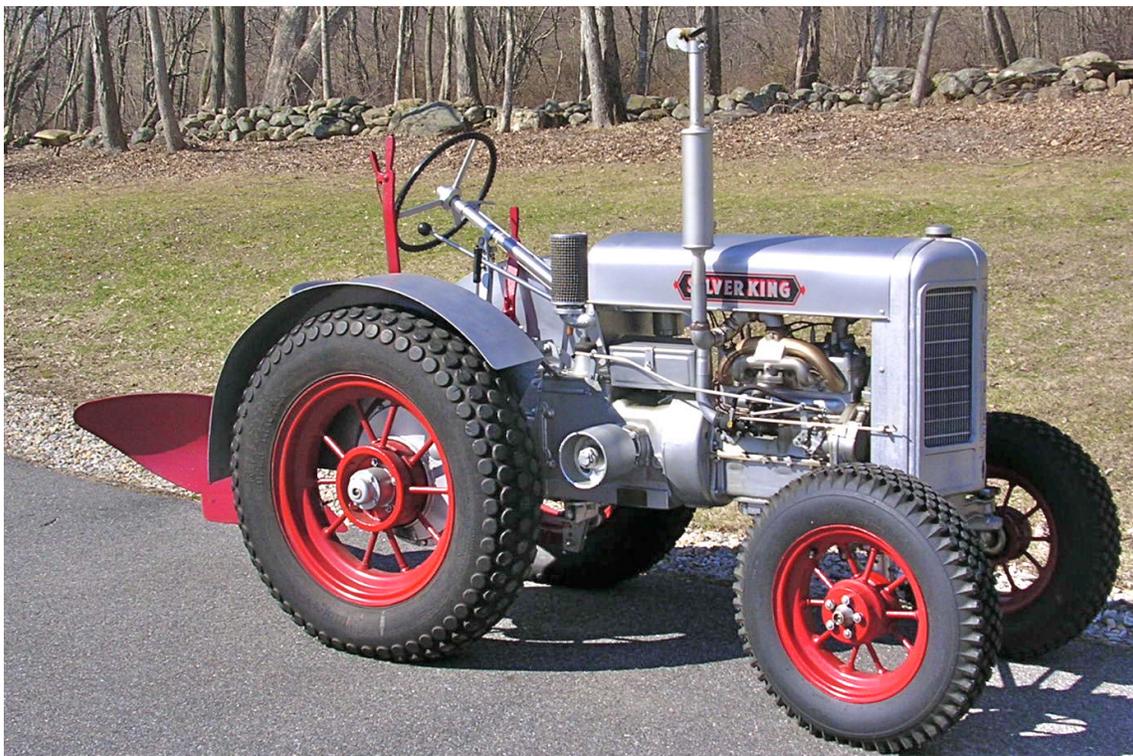
Later, I put it on the trailer and took it to show the old fellow who had it last. He was quite pleased and as I was about to leave he mentioned that he had the plow for it. Showing it to me over in a patch of weeds, he said I could have it if I wanted it. Looking through the weeds and grass, it appeared to be nearly complete. Having seen these plows mounted on Plymouths and Silver Kings at the show in Plymouth, Ohio, I certainly wanted it and went and picked it up a few days later. What I found with a closer look at home was a lot of rust and comparing it to the parts list in the tractor manual showed that all but one or two parts were there. Disassembly for sandblasting confirmed what

happens when steel sits out in the weather for twenty years or more. Some bolts came undone, some broke and some had to be cut. Even then, the plowshare, land-side, frog and moldboard could not be separated. All the parts were taken for sandblasting and a

coat of primer. Meanwhile the search was started for replacement bolts and nuts. The primed parts sat in the way for over a year until February 2003 when a fit of ambition took hold and reassembly was undertaken. My unintelligible disassembly notes were figured out and the levers, latches, springs and supports pieced together. Some pictures taken of the previously seen mounted plows were most helpful. A few parts had to be fabricated and some straightened. When the weather warmed up, the painting, red to match the wheels, was done and the plow mounted on the tractor in place of the drawbar and support. The plow is an Oliver model F1134. The whole plow showed a lot of wear just as the tractor did. There won't be any plowing demonstrations with those original worn down knobby tires on the tractor and fresh paint on the plow, just some show time. The plow remains installed and adds quite a bit of interest to the tractor at shows.
